# NISSAN DIESEL AMERICA, INC. RECALL BULLETIN

DATE: APRIL 10, 2000  
MODEL YEAR: 1995 ~ 1998  
MODELS AFFECTED: UD1800/UD2000/UD2300/UD2600/UD3000  
BULLETIN #: SC - 059  
FILE AT THE END OF THE ENGINE SECTION OF THE TECHNICAL BULLETIN BINDER

VOLUNTARY SAFETY RECALL CAMPAIGN #00V - 059:  
1995 ~ 1998 MODEL YEAR MEDIUM DUTY VEHICLE STOP MOTOR INSTALLATION

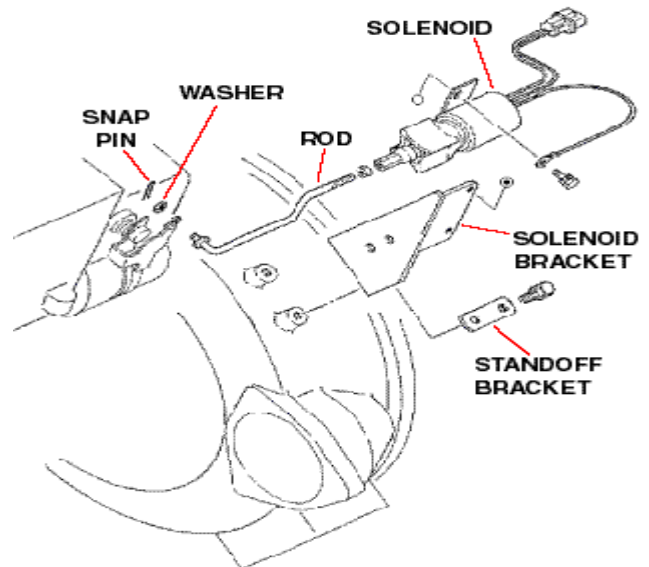
FIGURE 3

The possibility exists that the fuel injection pump shutdown solenoid of the involved vehicles may have insufficient water-proof protection of the electromagnet solenoid coil windings. Under isolated conditions, water entry into the internal coil windings of the solenoid can cause the windings to short circuit and not allow the vehicle to start. This condition does not occur during vehicle operation.

3. Remove the shutdown solenoid, mounting bracket, and solenoid rod by removing the snap pin and washer on the injection pump lever and by removing the two (2) bolts attaching the solenoid mounting bracket to the engine flywheel housing. Reattach the battery cable standoff bracket using one of the removed bolts. Retain the snap pin and washer for later use but discard all other removed parts. See Figure 3 on the right.
