SERVICE NEWS LETTER 060 (REV.)

AISIN AUTOMATIC TRANSMISSION OUTPUT FLANGE NUT SERVICE PROCEDURE

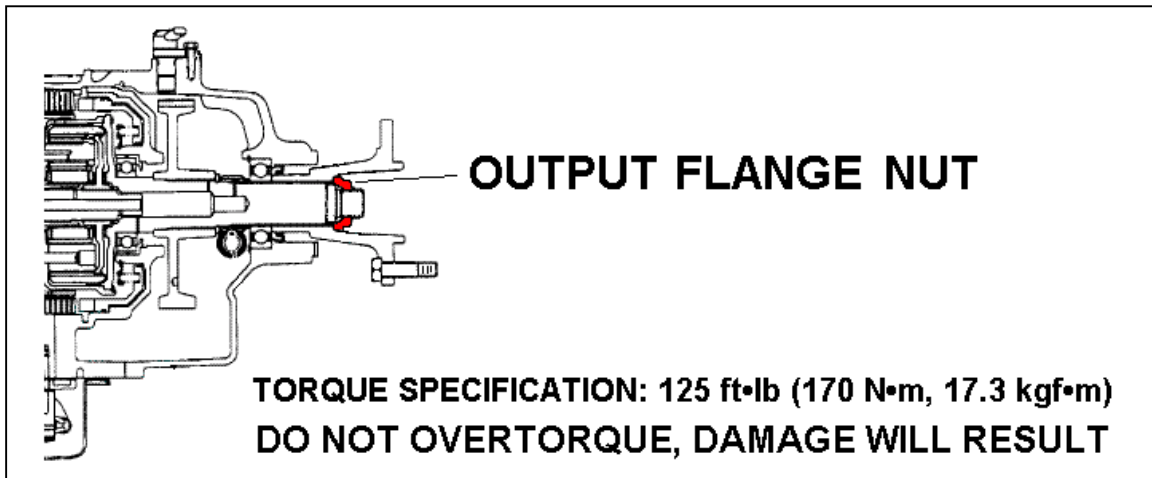
STAKE NUT WITH CHISEL

- Whenever repair or service procedures require the removal of the output flange nut on the Aisin automatic transmission, it is recommended to install a new nut (part number 33143-29D00). New nuts are provided on all Genuine UD replacement or UD Remanufactured units.
- Using a blunt chisel, stake the nut onto the output shaft as shown.
