## SUBJECT: Front Cab Mounting Squeak or Rattle

Department: Service  
 Section: Engine  
 Model(s): All  
 Model Year(s): 2011—2013  
 Effective Date: 9/14/2012  
 Form #: TSB CB-09  
 Rev #: n/a  
 Supersedes:

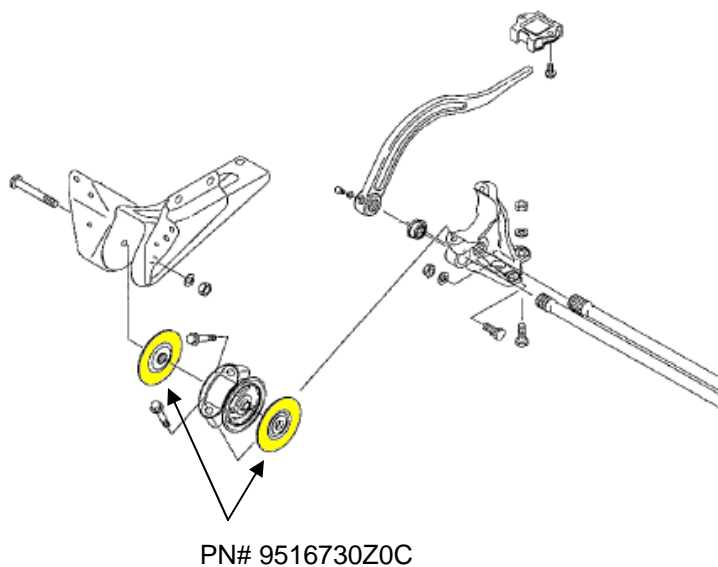
**Cause:** After cab installation on the chassis, there is an interference between the tilt-hinge housing and the side cushions.

Replace the side cushions at the tilt hinge with revised cushion PN# 9516730Z0C as illustrated below.

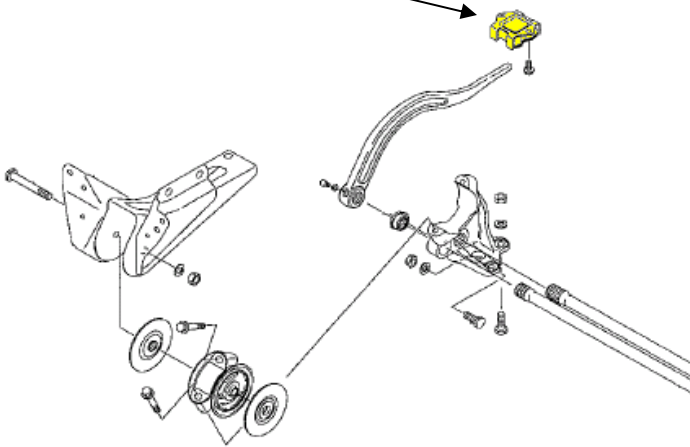
Cause: Insufficient clearance between the torsion arm and rubber contact seat.

Replace the rubber contact seat at the torsion bar arm with revised cushion PN# 5020430Z0C as illustrated below.
